PURCELL

BLACKBURN COTTON EXCHANGE HERITAGE STATEMENT

ISSUE 2
JUNE 2016

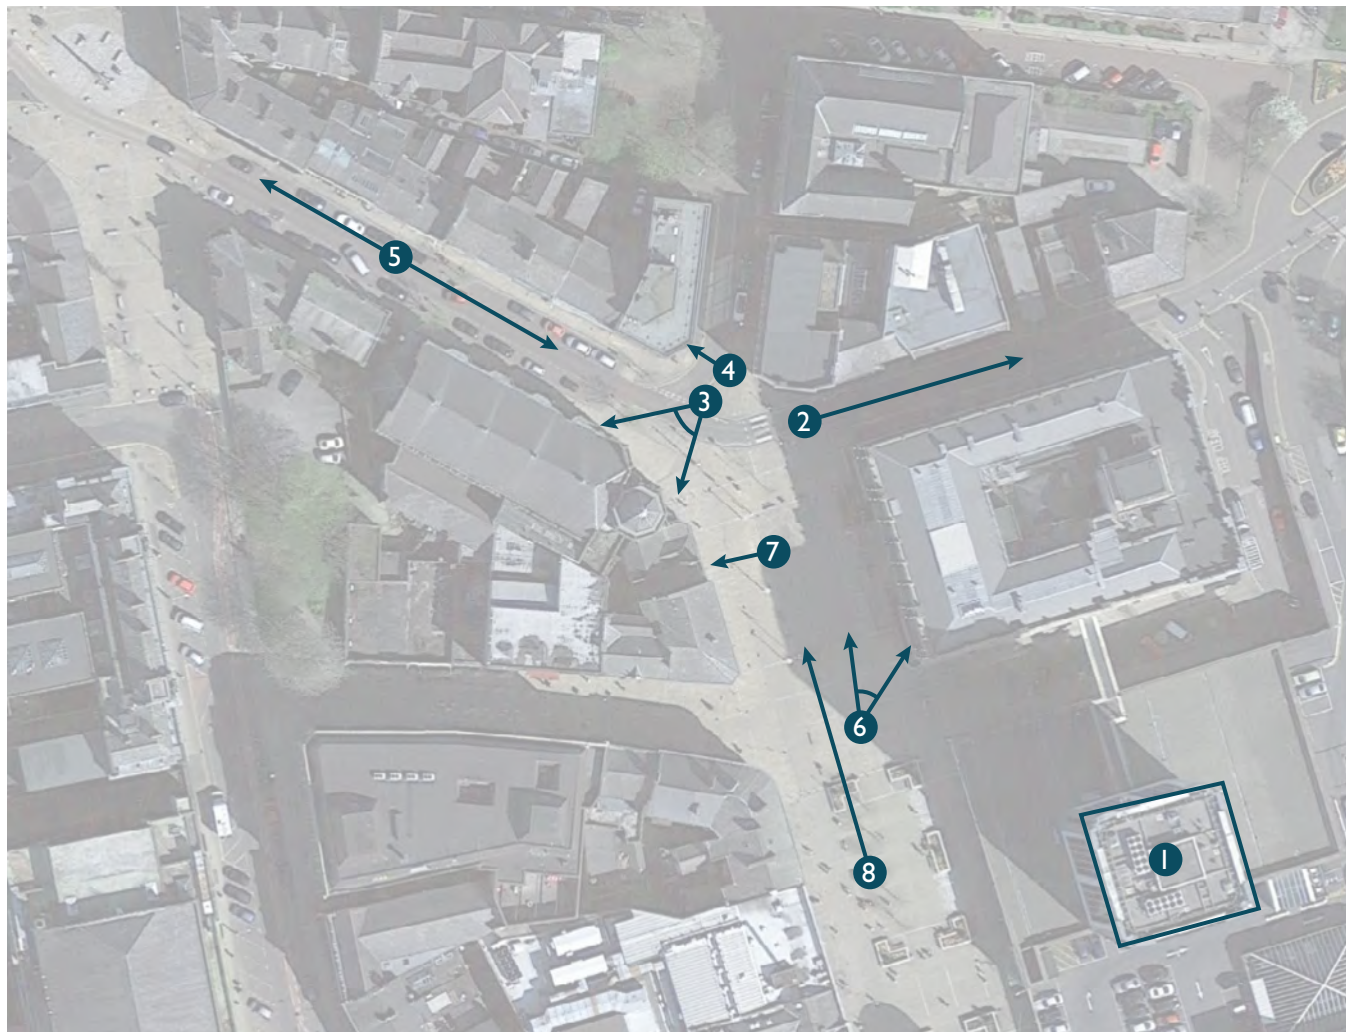
Significant views from the Blackburn Cotton Exchange

The key views on the adjacent plan have been chosen as they contribute to our understanding of the significance of the Cotton Exchange through their visual and historical relationship or associations between the site and other heritage assets in the area.⁰³

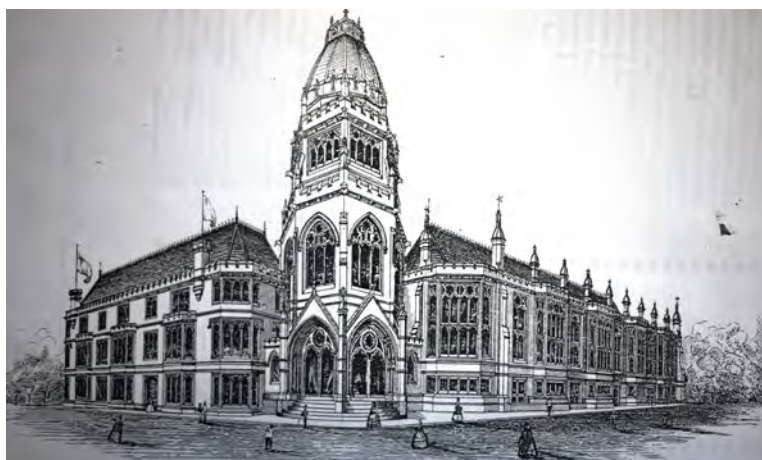
The winning design for the Blackburn Exchange Hall

The winning design by Brakespear of Manchester was commissioned and the northern range and octagonal tower was built between 1863 and 1865. The southern range was not completed.

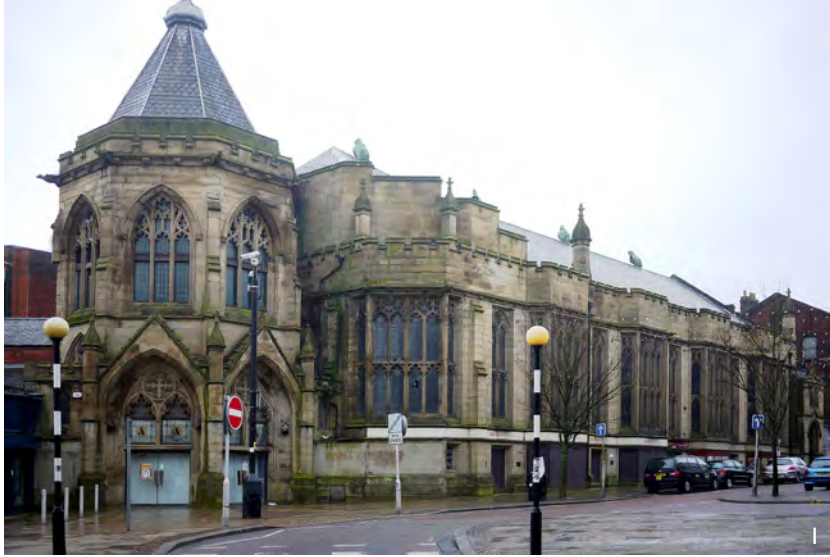
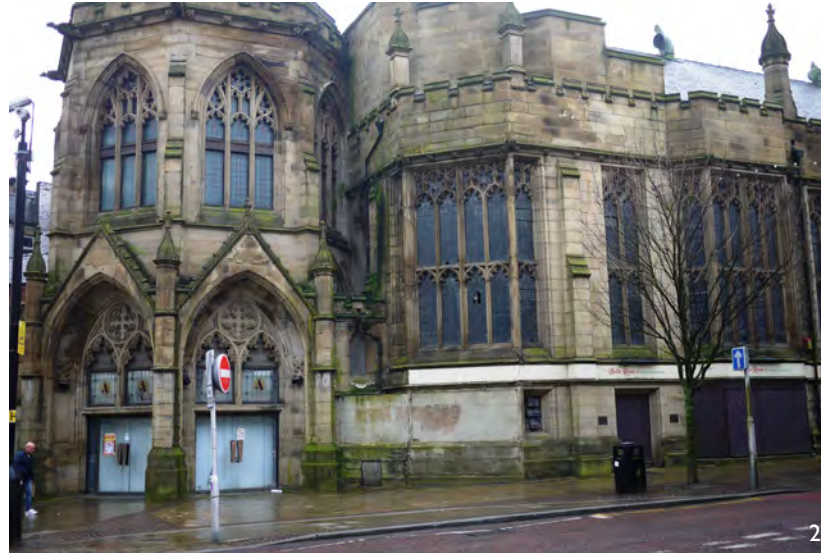
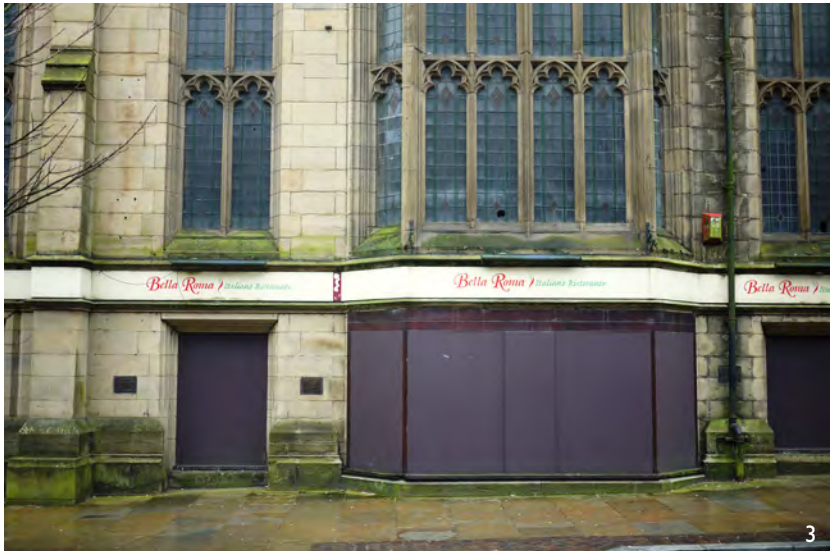
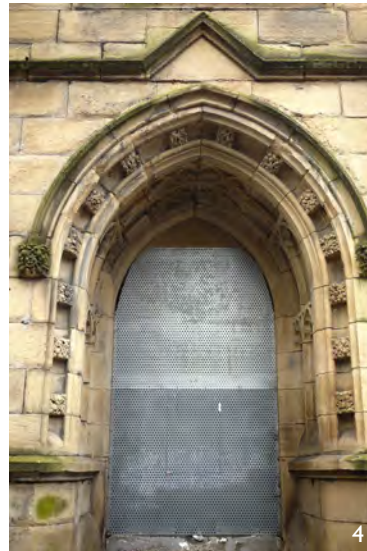
- 1 Cotton Exchange front entrance, east
- 2 Cotton Exchange front entrance, north-east
- 3 Cotton Exchange, Bella Roma restaurant windows, south
- 4 Side entrance along north elevation

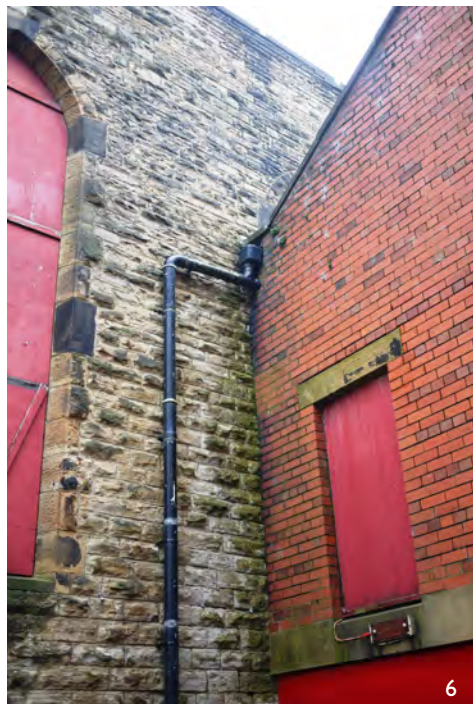
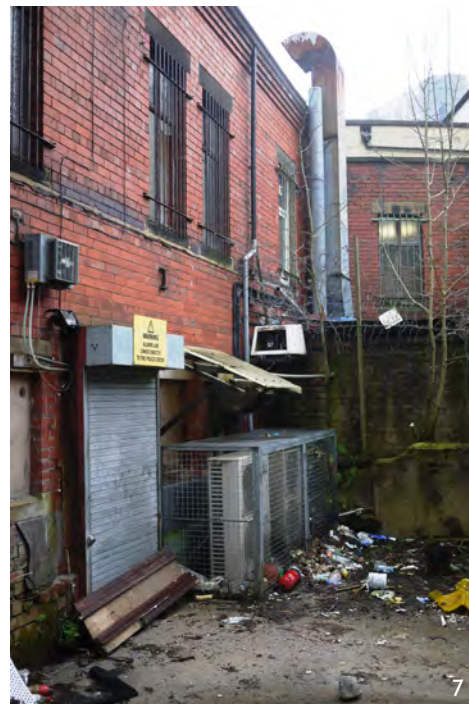
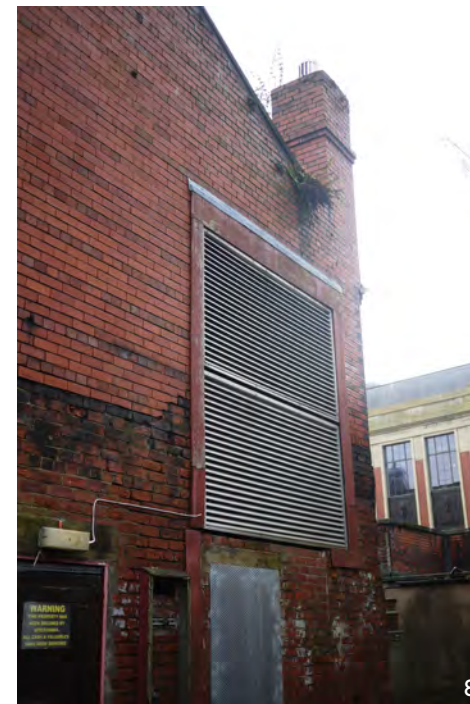
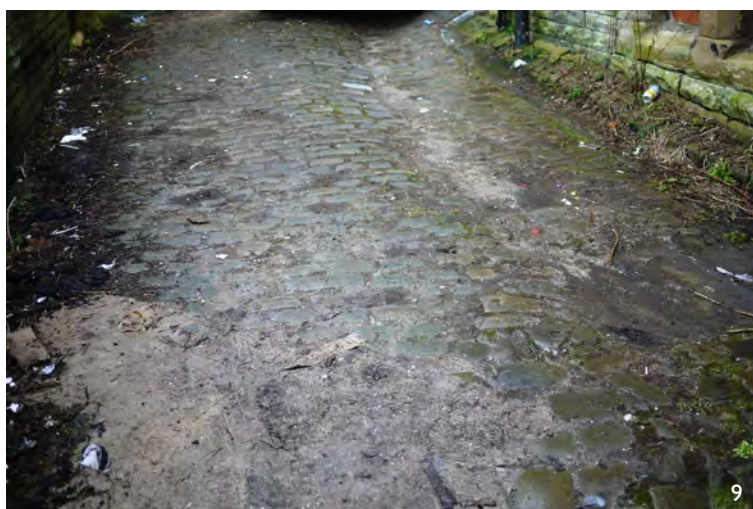
- 5 West elevation, accessed via sideroad off King William Street
- 6 South elevation and adjoining 1924 extension with modern brickwork, accessed via sideroad off King William Street
- 7 Modern additions to the rear, loading bay entrance, all of which is in bad condition
- 8 Exterior of modern plant room, with early 20th century at the base of the wall
- 9 Original rear access lane, with cobbled surface

The rear access alley of the Exchange Hall is an original feature and is surrounded by a low retaining wall beyond which is modern car parking. This rubble stone wall is in a poor condition.

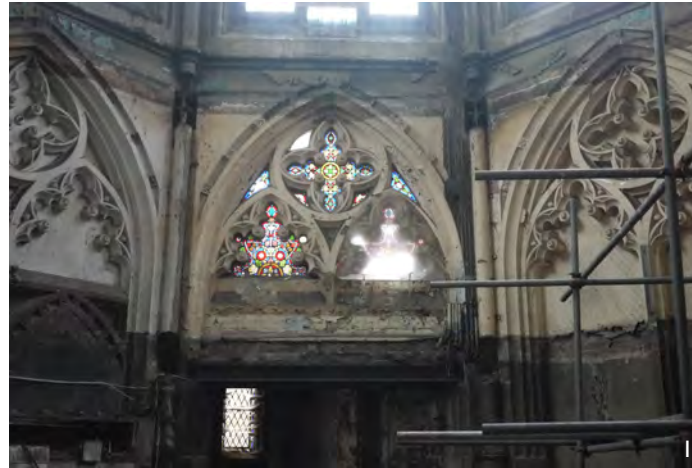
1 Remaining stained glass windows in main entrance octagonal lobby

Damage to the lobby space includes steel and timber beam insertions, brick blocked openings, loss of original tracery openings and damaged stonework. A reception kiosk was installed in the Entrance Lobby as part of the 1994 cinema conversion. The original arched openings in the form of pointed Gothic windows were used as doorways or windows but many have been cut off at head height and a steel beam inserted to widen openings. Stained glass survives in some of the window tracery.

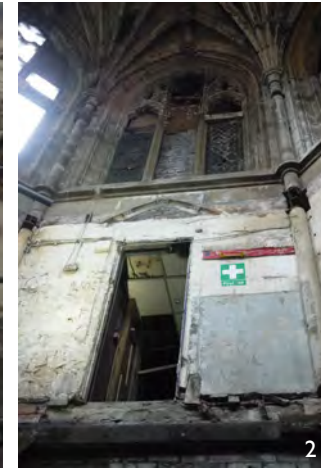
2 Doorway which once would have led to mezzanine level in main entrance octagonal lobby

Within the lobby were originally two small corner rooms, which are evidenced by the original skirting that can be seen above the current floor level. It is not clear what these small rooms were used for. The doors and floors have been removed, and these spaces would have been hidden from sight since at least the 1920s.

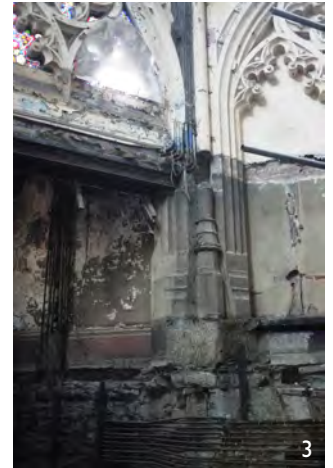
3 Main entrance lobby ceiling

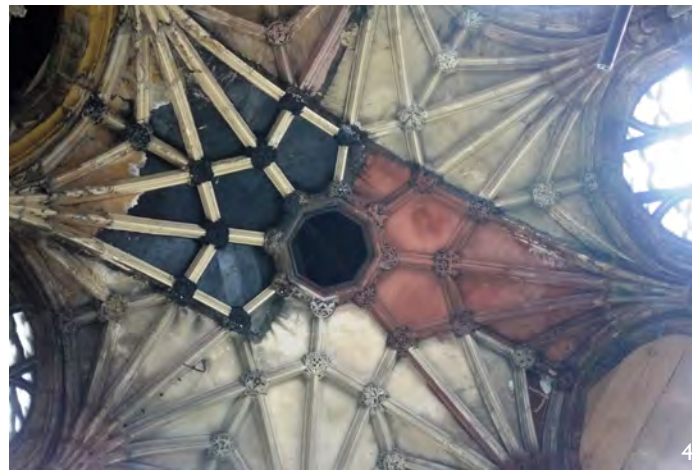
4 Main entrance lobby, pipework on display

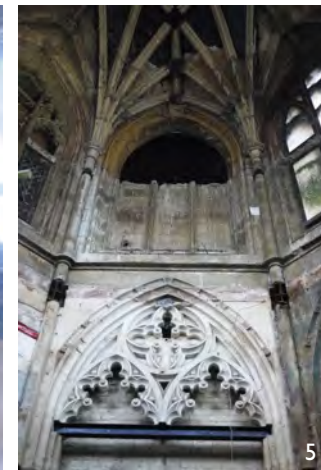
5 Main entrance lobby window remains

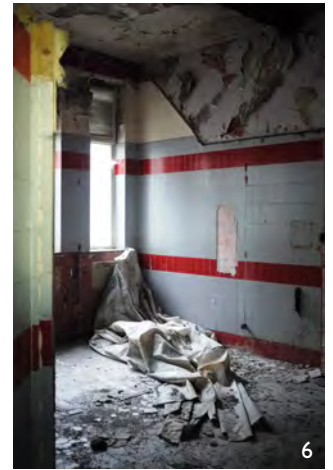
6 Remains of east end toilet

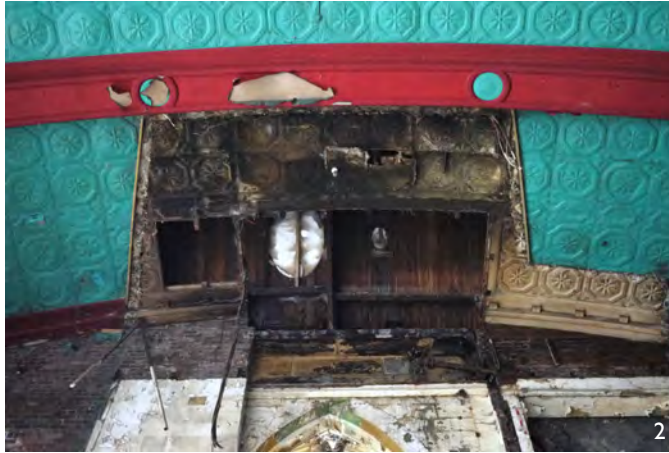
- 1 View from the west end of the north side windows
- 2 Section of the east end ceiling in the main hall
- 3 Remains of what are possibly early proscenium arch walls
- 4 Remains of the proscenium arch and cinema projection screen
- 5 View from the east end of the main hall

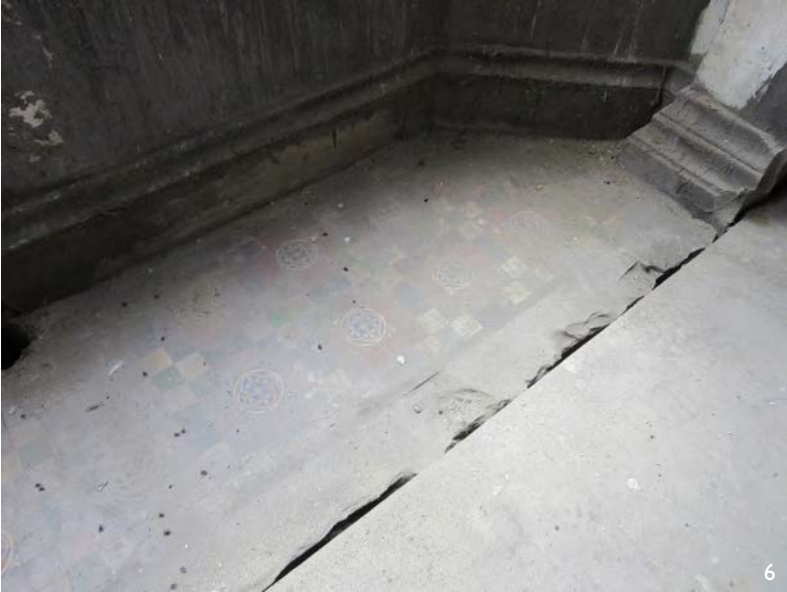
- 6 Victorian tiles within the window bays of the main hall
- 7 Example of the pressed-metal panels surviving on the main hall walls
- 8 Stone corbel within the main hall indicating the form of the original roof

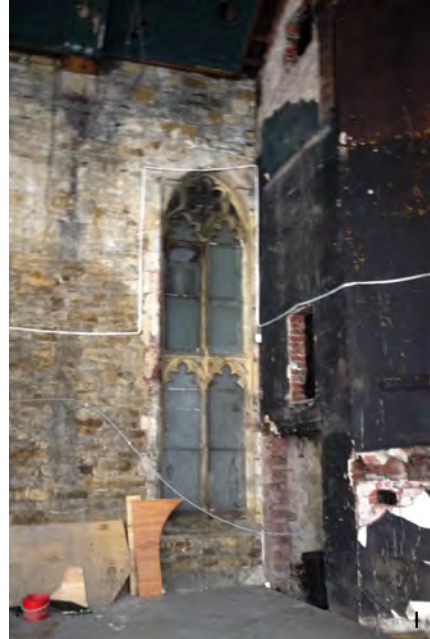
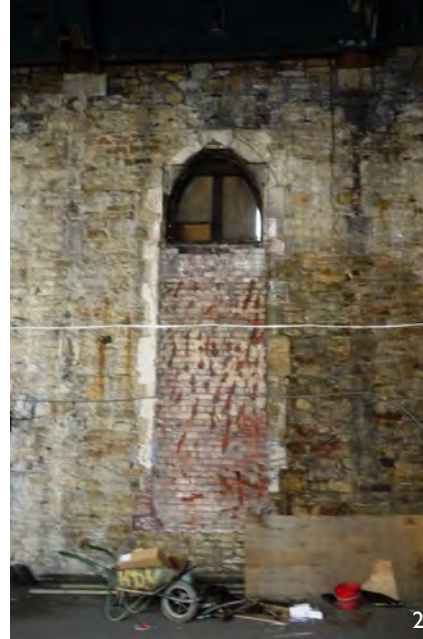
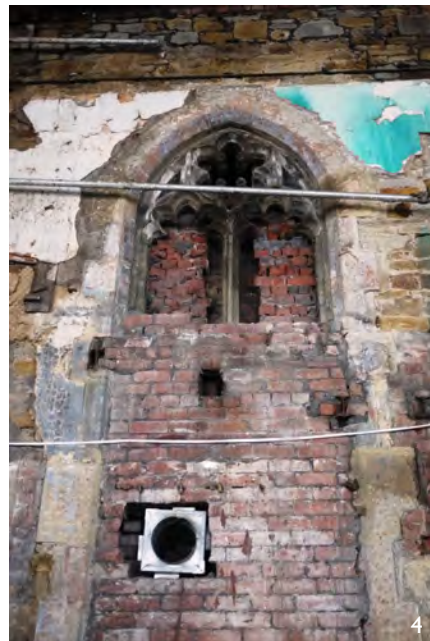
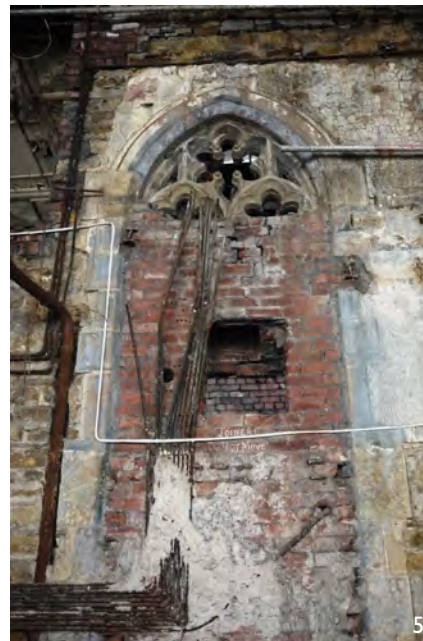
REAR WINDOWS

The rear windows are single lancet Gothic openings in an Early English style. Each window has suffered a different degree of loss. The photographs here record each window and its level of alteration or survival.

- 1 South elevation, western window original remains
- 2 South elevation, partial modern brick infill in window remains
- 3 South elevation, window with modern brick infill, sections removed
- 4 South elevation, partial modern brick infill with original window remains
- 5 South elevation, original window remains, with modern brick infill, plumbing, and wiring

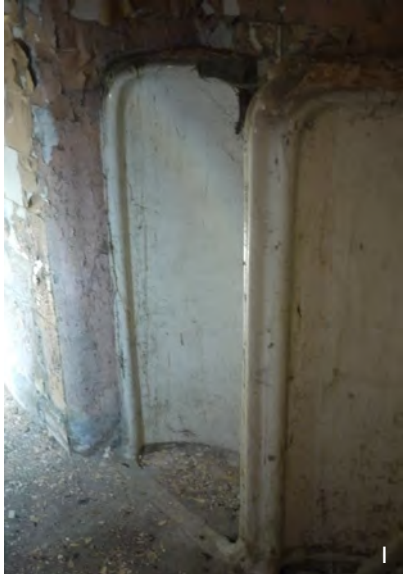
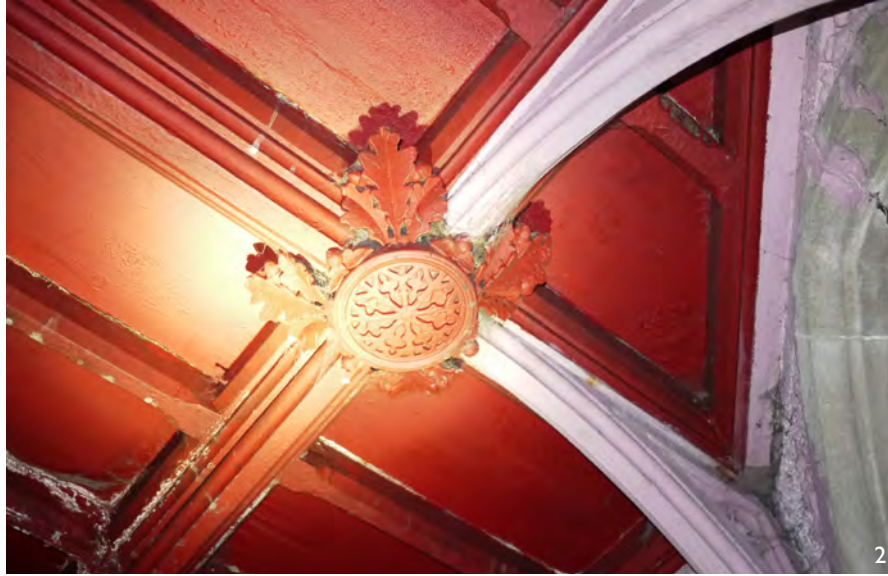
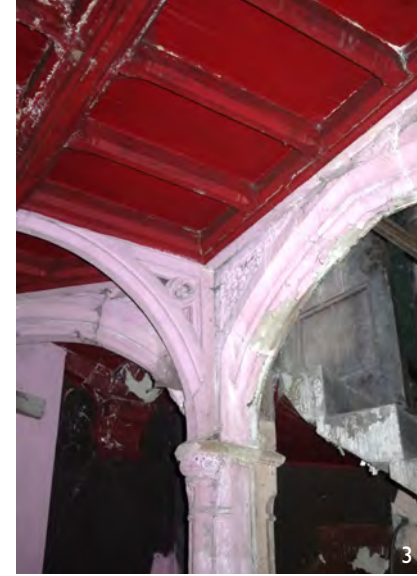
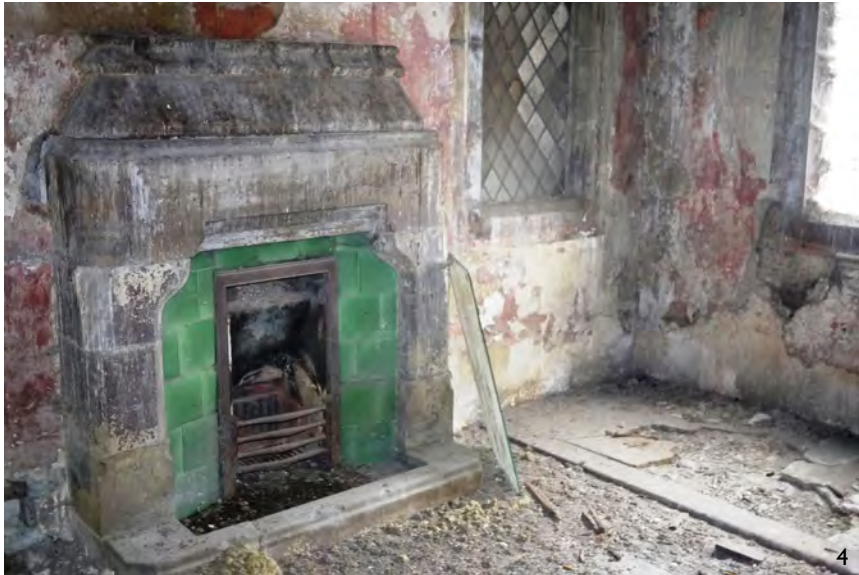
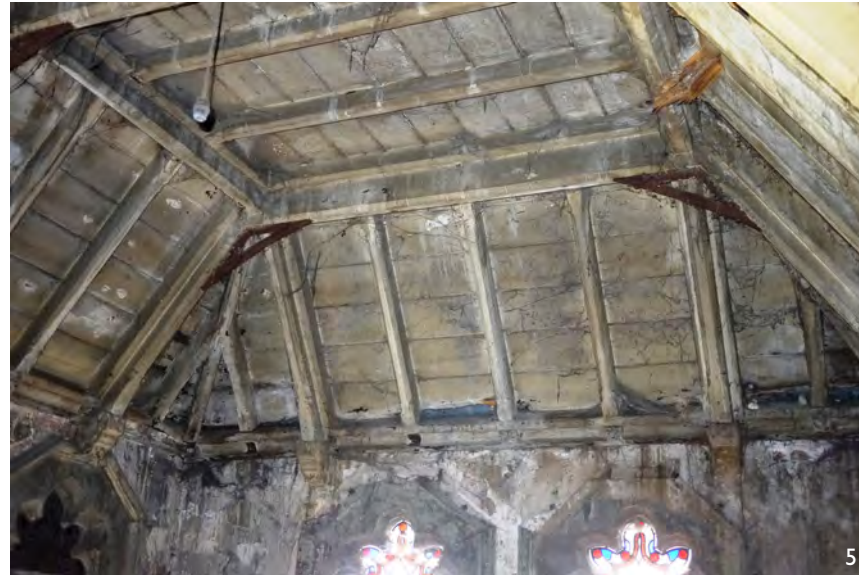
1 West end, basement level, bathroom

2 West end, north, stairway ceiling

- 6 West end, north, mezzanine level, original paint scheme and door
- 7 West end, north, stairway leading to mezzanine level
- 8 West end, rose window, and remains of proscenium arch
- 9 West end, unsure on what the doorway was leading to, potentially a balcony, evidence is missing
- 10 Fireplace beneath the stage that matches that in the first floor

had two flights that joined at the top to give access to the upper floor WCs and the upper auditorium. The stone steps have been hacked off, leaving scars flush with the wall. This area also has pressed-metal ceiling panels, in a different design. Many of the tin panels have corroded and are in a poor condition. A large flat skylight let light into the space but the glazing has been removed.

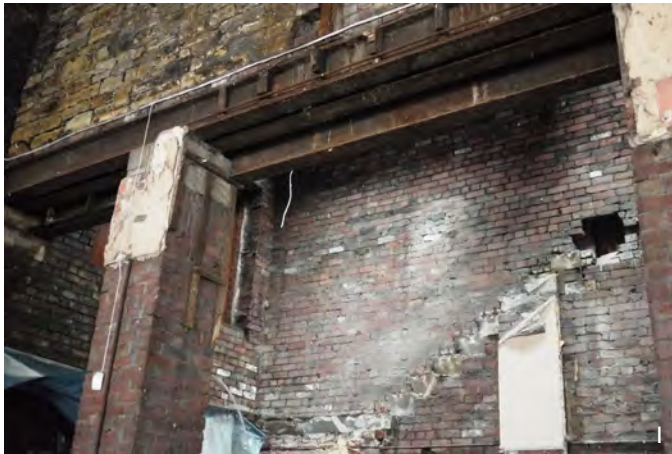
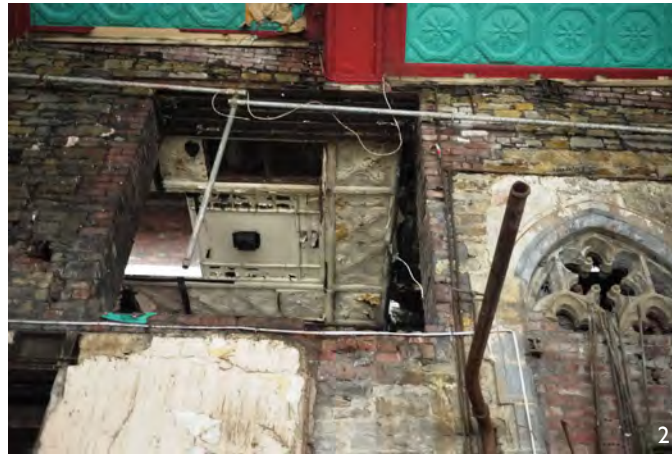
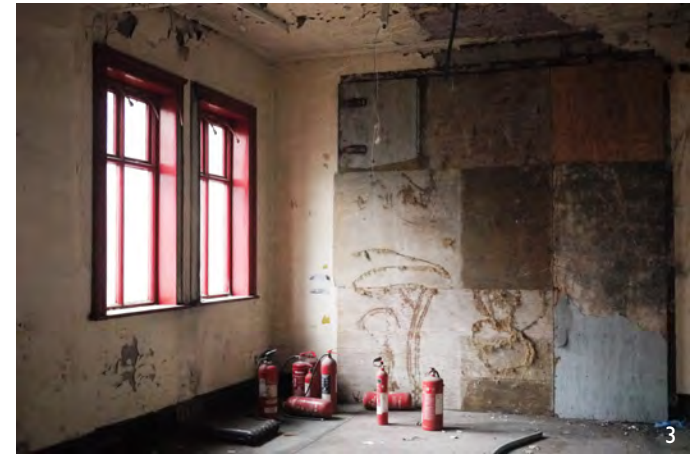
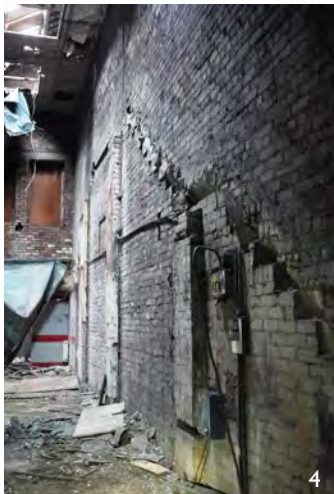
- 1 Supporting steel frame to support the original wall where they removed sections to make way for doorway to the southern extension
- 2 Section removed from the original southern wall
- 3 Room in section of southern extension
- 4 South elevation, extension, remains of a stairway which would have lead to a mezzanine level
- 5 South elevation, extension, doors of bathrooms on the once existing mezzanine level
- 6 Red pressed metal panels

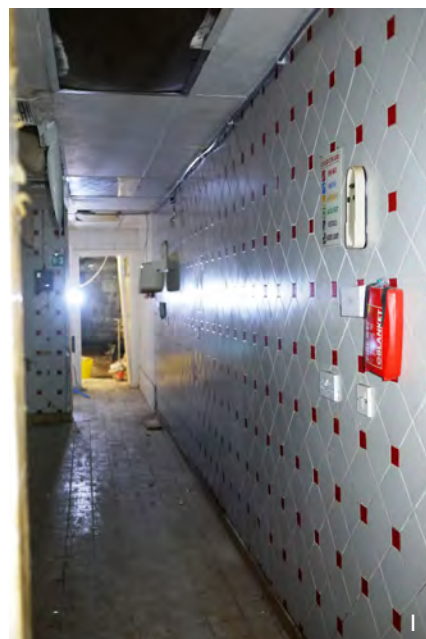
- 1 Rear circulation space kitchen fit-out
- 2 Circulation and services spaces within the rear of the basement
- 3 Evidence of the stone roof structure above modern ceiling tiles
- 4 Basement level, southern extension, original and early 20th century brickwork with modern electrics

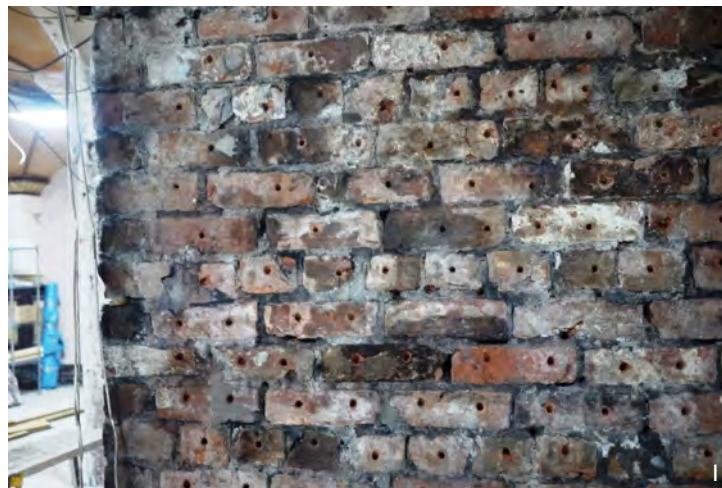
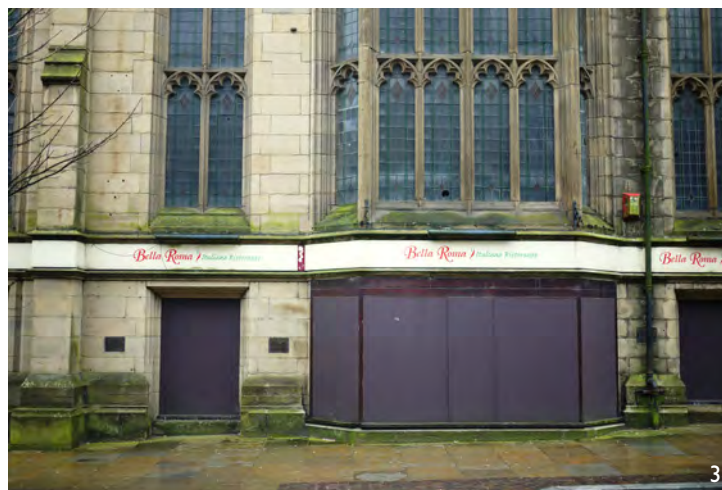
- 1 Modern brick wall, drilled hole markings created during the treating of dry rot
- 2 The remains of where a pillar has been removed during the extension
- 3 Modern restaurant front, north elevation, taken from King William Street

In the areas that modern fabric has been stripped off (partly to deal with an outbreak of dry rot) the original stone and brickwork can be seen, revealing many alterations and a succession of interventions over the years. Some areas of stone masonry can be seen at the east end, but other areas are of rubble blockwork and many areas of infill brick can be seen. It has not been possible to date each intervention into the fabric; however, many of the changes to the south relate to the 1920s additions. These include large openings in the original rear wall of the Exchange Hall basements and blocked windows. Concrete lintels, steel beams, cinder blocks, ventilation, pipework and modern brickwork all illustrate later 20th century alterations.

In some areas a treatment for dry rot has been inserted into the historic fabric by injecting resin into the bricks and stones themselves. This is potentially harmful to the historic fabric but may be considered necessary to halt the advance of decay elsewhere. Work has also been carried out to limit water ingress in places, which is beneficial to the condition of the building.

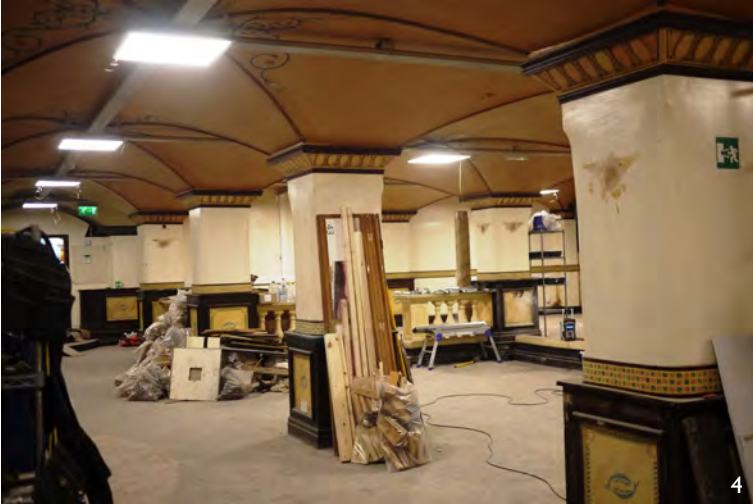
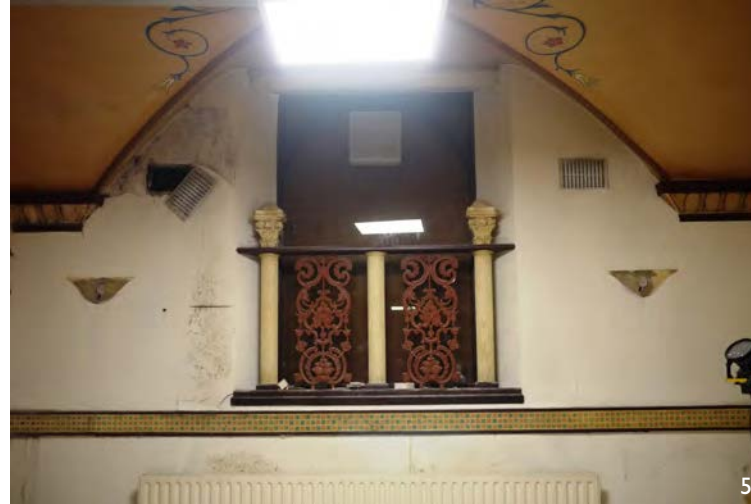
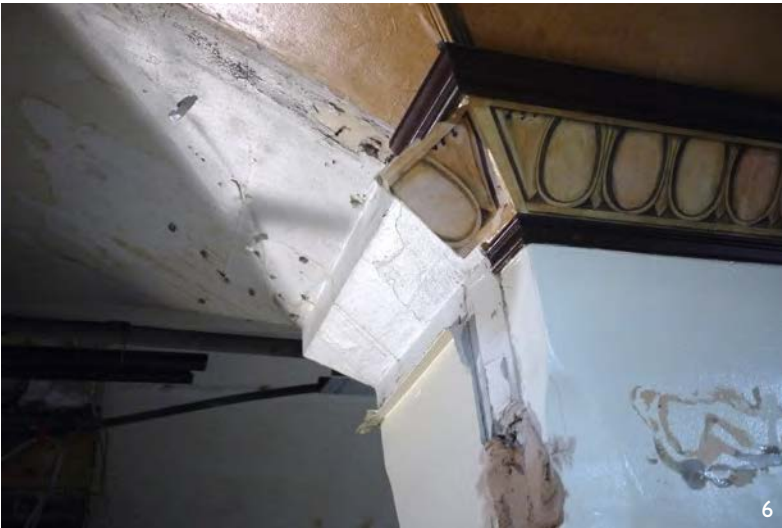
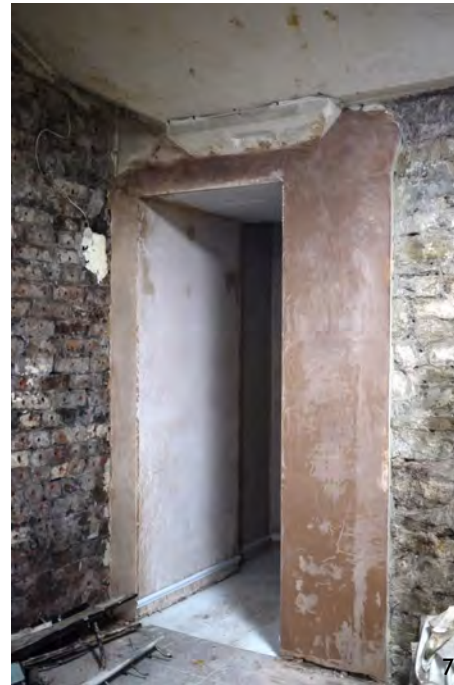
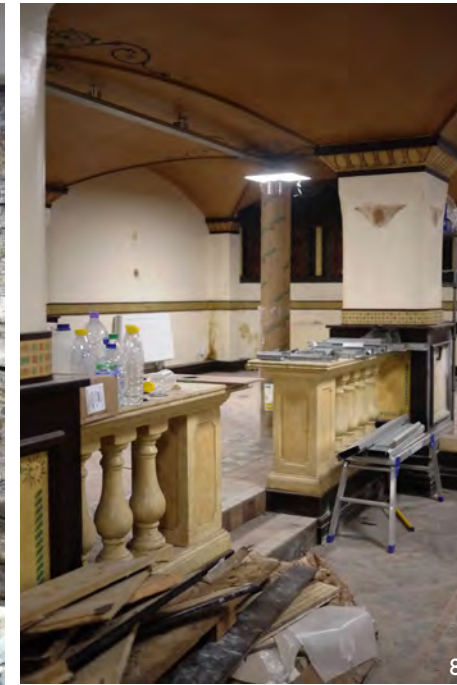
- 4 Basement restaurant, 21st century paint work, original pillars, however, they have been plastered over
- 5 Boarded over window, with modern shop additions
- 6 Basement supportive pillar with modern restaurant wallpaper.
- 7 Entrance way into restaurant bathrooms
- 8 Modern restaurant raised floor elevation

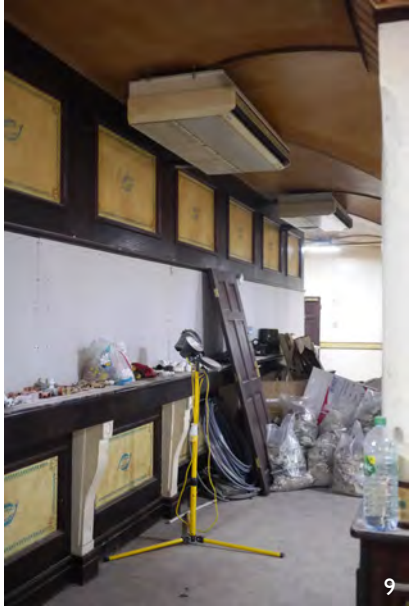
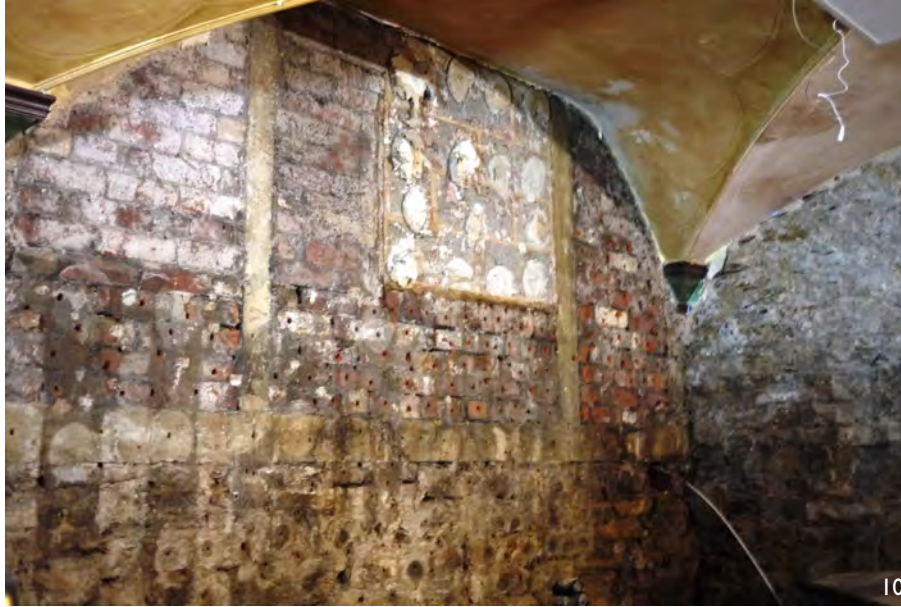
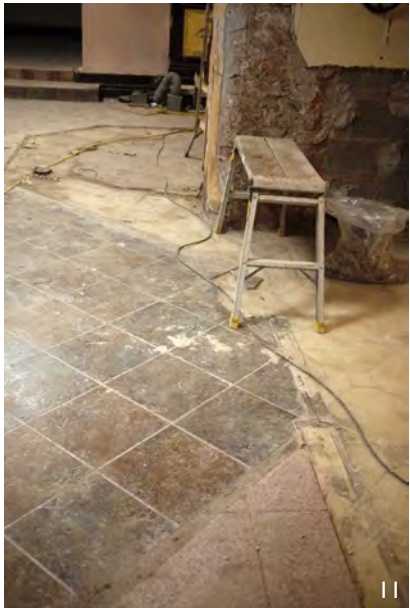
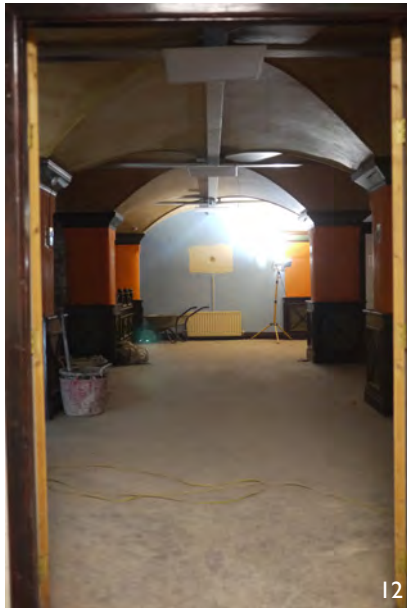
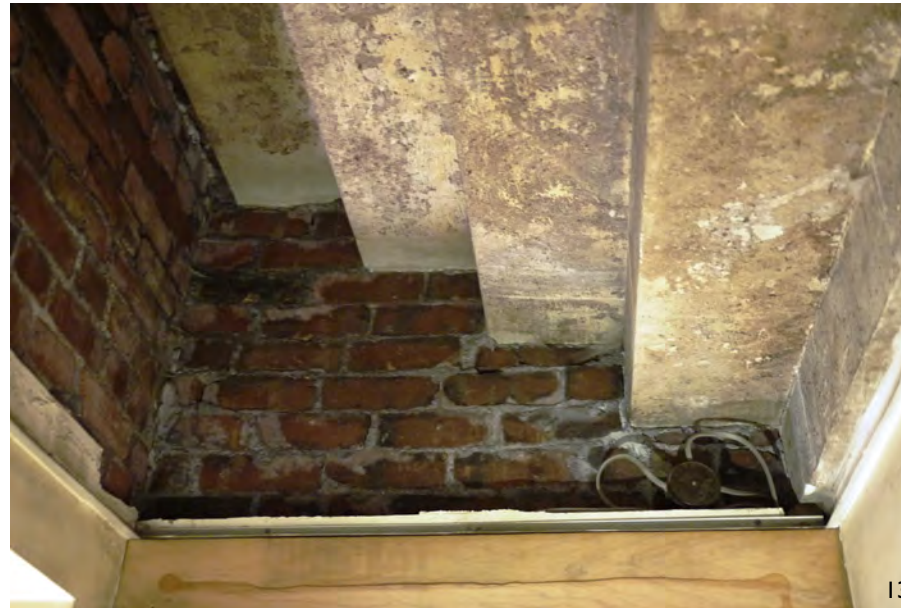
- 9 Main restaurant bar
- 10 Blocked stone window on the rear elevation
- 11 Modern tiled flooring
- 12 Additional bar, west end
- 13 Underside of stairs leading from ground floor lobby to main hall rotate anti-clockwise 90°

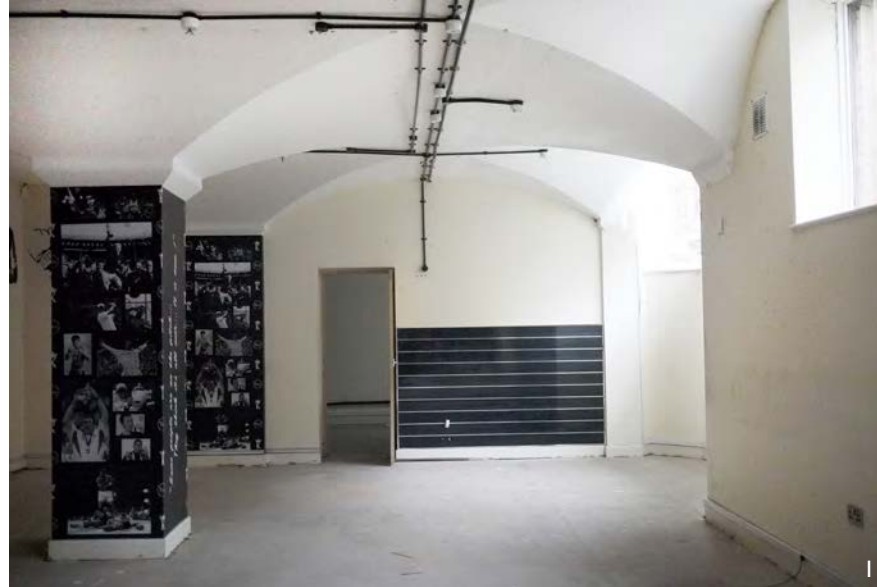
To the north-west of the basement is a separate shop unit that has been divided from the main space with modern plasterboard partitions. Several of the original piers have been removed from this unit to create the new walls. This space was most recently used as a hairdressers and retains a modern decorative scheme including wall colours and coverings.

- 1 Modern shop unit, north-west
- 2 Modern fire exit, with original brick vaulting

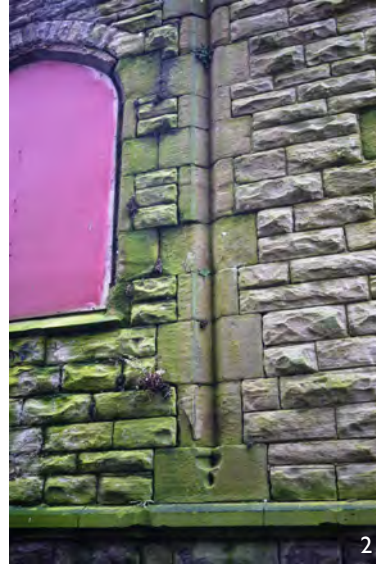
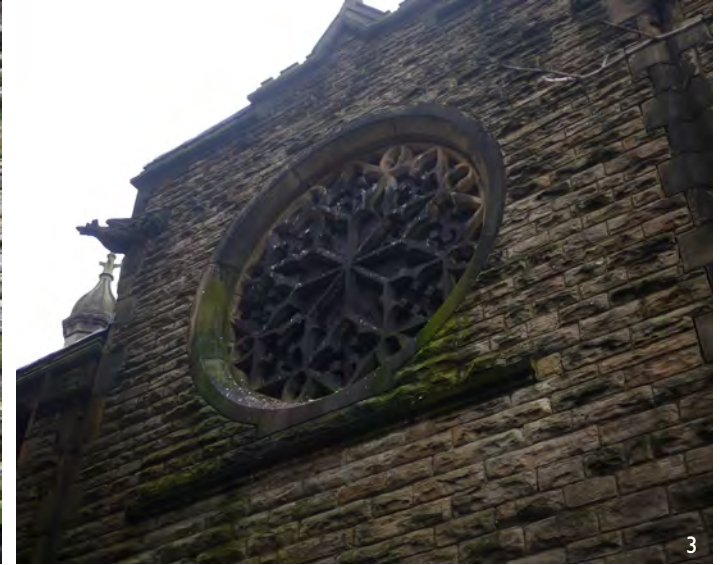
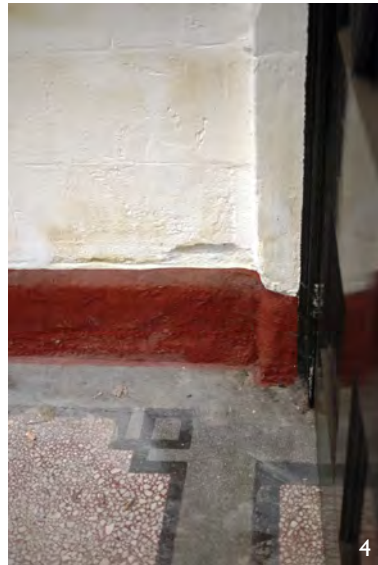
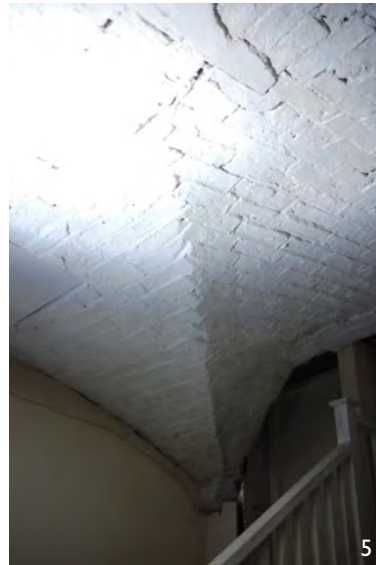
- 1 Detail of the decorative carvings on the north side entrance
- 2 West elevation, brick indent of where a drain pipe would have originally been
- 3 West elevation, rose window
- 4 Street level entrance to basement floor, north, modern skirting board and flooring
- 5 Basement vaulted ceiling, south west corner.

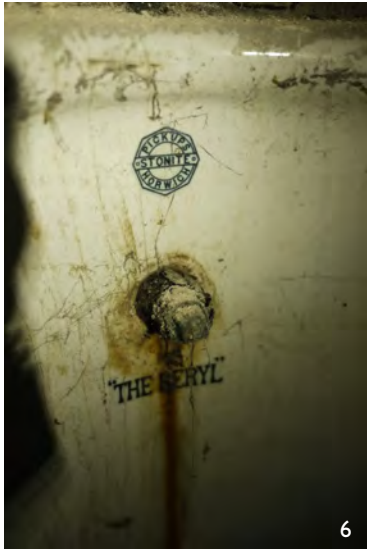
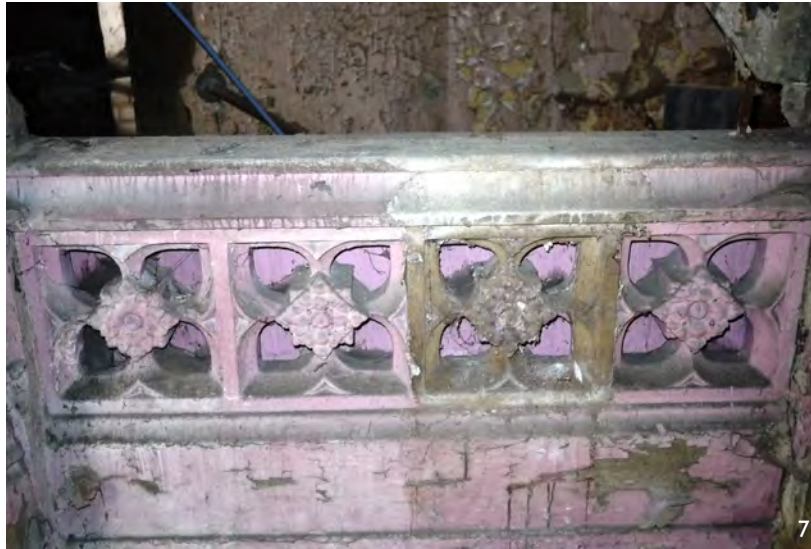
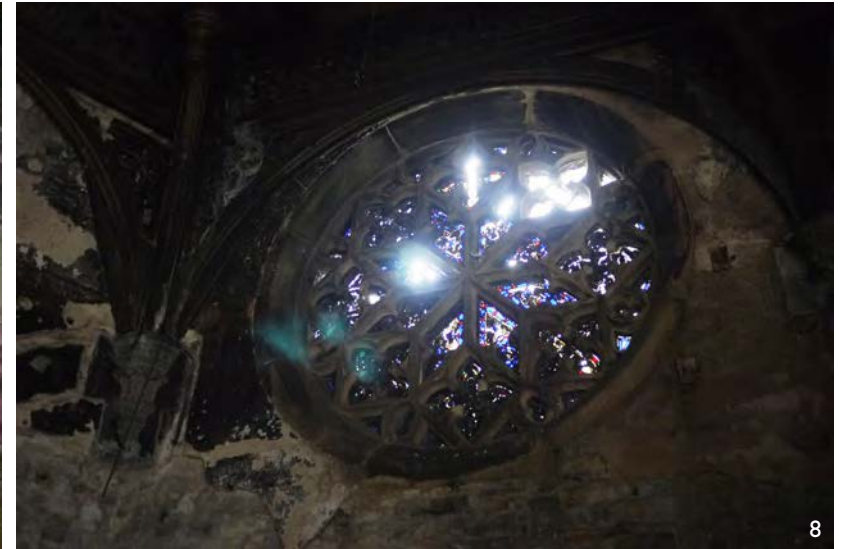
- 6 Early 20th century urinals
- 7 Original build banister, with original paintwork, north west stairway
- 8 West elevation, rose window
- 9 Pressed-metal ceiling in 1924 southern extension
- 10 1924's ceiling adjoining to the original southern wall, remains of plastering is still visible
- 11 Southern extensions poor conditions

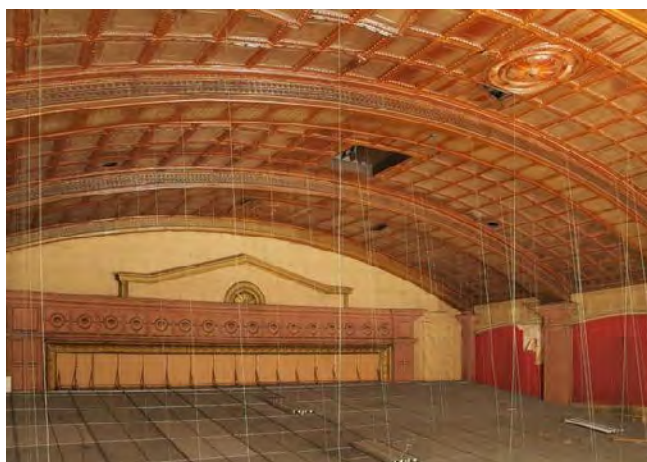
The barrel vaulted, pressed-metal ceiling at the Curzon Cinema in Clevedon, built 1920-22
